# **INDOOR AIR QUALITY ASSESSMENT**

**East Brookfield Town Hall/Library  
122 Connie Mack Drive  
East Brookfield, Massachusetts**

Prepared by:  
Massachusetts Department of Public Health  
Bureau of Environmental Health  
Indoor Air Quality Program  
November 2016

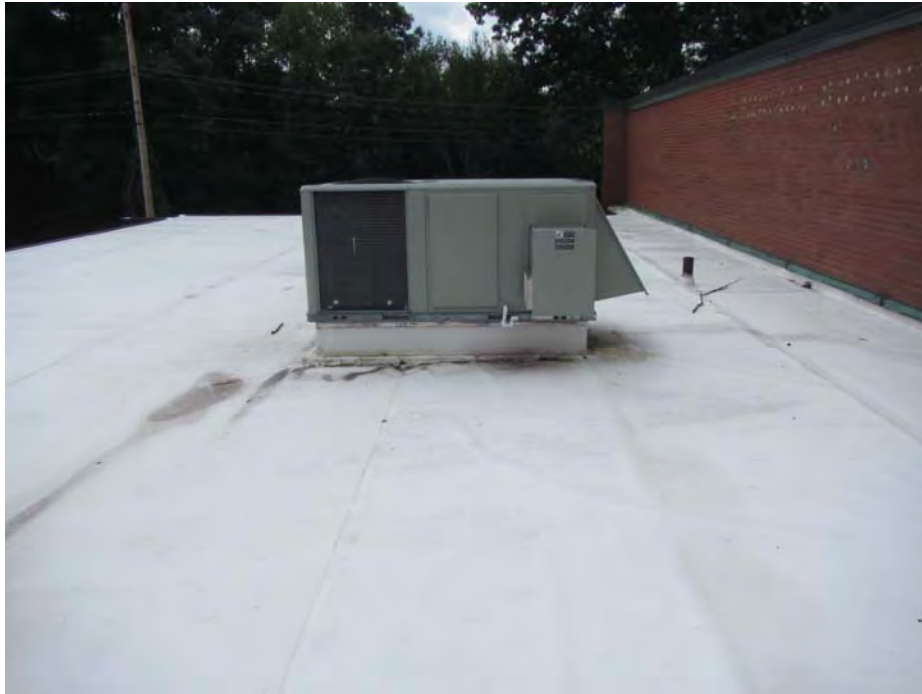
**Picture 1**

Fresh air is provided by an air handling unit (AHU) located on the roof (Picture 1). Air from the AHUs is filtered, heated/cooled, and delivered to rooms via ducted supply vents. Air is returned/exhausted through vents in the ceiling.

On the roof, fresh air is drawn into the AHU through an air intake. Air is exhausted from the AHU through a vent with moveable louvers. The AHU is designed to have air bleed from the AHU through these moveable louvers. The orientation (facing west) of the AHU with respect to the prevailing wind can allow uncontrolled entrainment of cold air during winter through the passive louvered exhaust vent. Prevailing winter winds are generally northwestern (Picture 3).

This airflow can lift the edge of the passive vents and force outdoor air into the return air chamber. The condition is enhanced by lifting of the exhaust vent louvers when return vent louvers restrict airflow. In the winter this condition can introduce cold air that may result in the AHU coils freezing. During warm, humid weather, uncontrolled air introduction can result in increased condensation inside the AHU cabinet.

**Rooftop air handling unit (AHU)**

1. Repair all frozen AHU exhaust vent louvers.
  2. Consider installing a chimney on each AHU over the heating exhaust vent at a height two feet minimum above the top of the AHU cabinet.

3. Install a hood over the AHU louvered exhaust vent to limit possible wind impingent.
  4. Operate supply and exhaust ventilation in all areas during occupied periods.

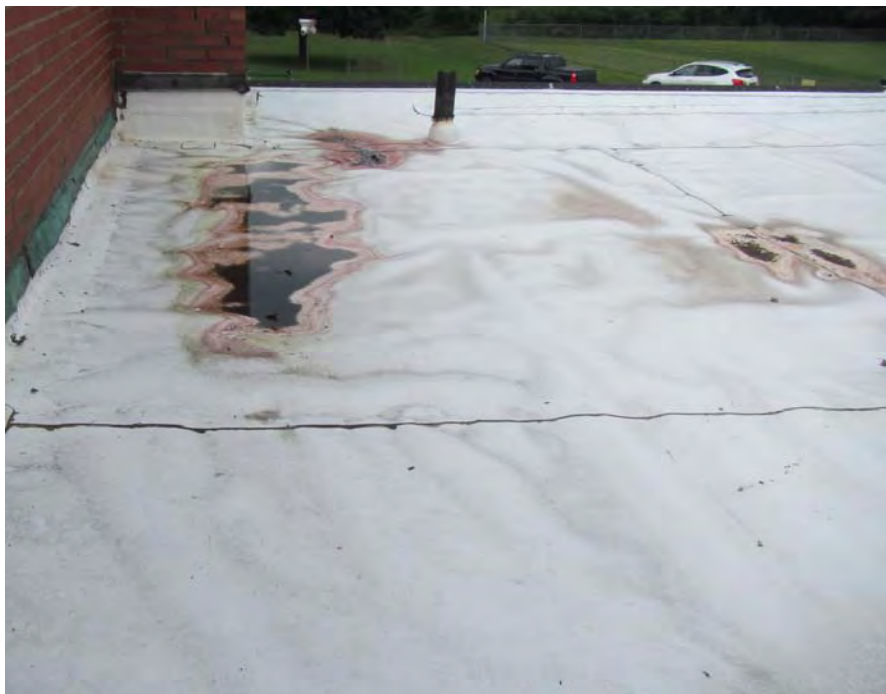
**Picture 2**

Water-damaged ceiling tiles were observed in a number of areas. Some of the observed stained tiles were from roof leaks that have reportedly been repaired. The roof of the building was also examined. The roof membrane had become loose resulting in pooling water (Picture 2). Debris is also present from tree branches that overhang the roof (Picture 3). Debris holds moisture on the roof, which can damage the membrane and can be attractive to pests.

**Loosened roof membrane**

5. Have the HVAC system balanced every 5 years in accordance with SMACNA recommendations (SMACNA, 1994).
  6. Repair damage to the roof on an as-needed basis.

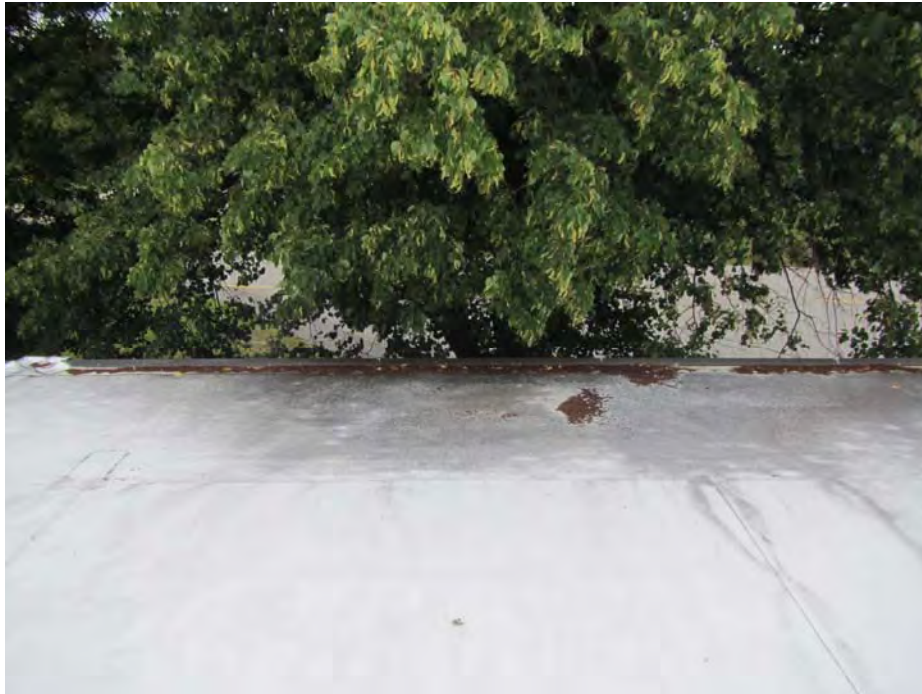
**Picture 3**

**Debris on the roof from overhanging tree branches**

7. Replace water-damaged ceiling tiles once any contributing leaks are repaired.
  8. Clear debris from the roof. Consider removing tree branches overhanging the roof.

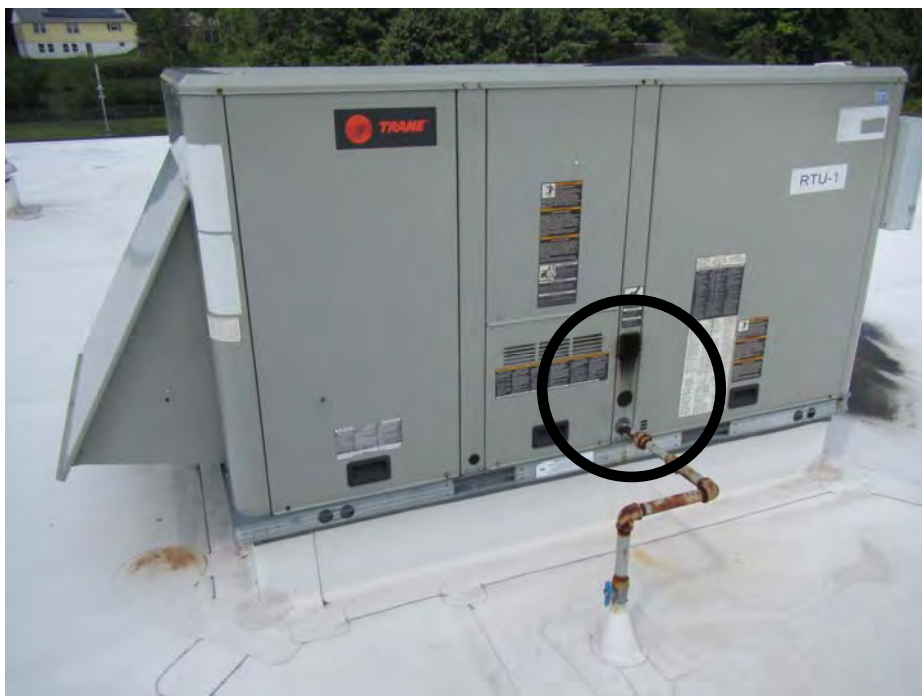
**Picture 4**

All of the AHUs on the building contain a natural gas combustion system that is used to provide heat to the coils. The products of combustion from the natural gas are vented from the side of each AHU (Picture 4). It is possible that products of combustion from the AHU exhaust vent may be directed toward the fresh air intake hood under certain wind conditions. With sufficient air velocity drawing air into the AHU, these products of combustion may be entrained by each AHU and distributed to occupied spaces.

**Gas exhaust vent on AHU, note it is blackened by soot (circle)**
